# Cause Analysis for a New Type of Devastating Flash Flood

**Abstract:** This work introduces an unprecedented flash flood that resulted in 9 casualties in Shimen Valley, China, 2015. Through field survey and numerical simulation, the causes of the disaster are systematically analyzed, finding that the intense storm, terrain features and the large woody debris (LWDs) played important roles. The intense storm induced fast runoff and, in turn, high discharges as a result of the steep catchment surfaces and channels. The flood flushed LWDs and boulders downstream until blockage occurred in a contraction section, forming a debris lake. When the debris dam broke, a dam-break wave rapidly propagated to the valley mouth, washing people away. After considering the disaster-inducing factors, measures for preventing similar floods are proposed. The analysis presented herein should help

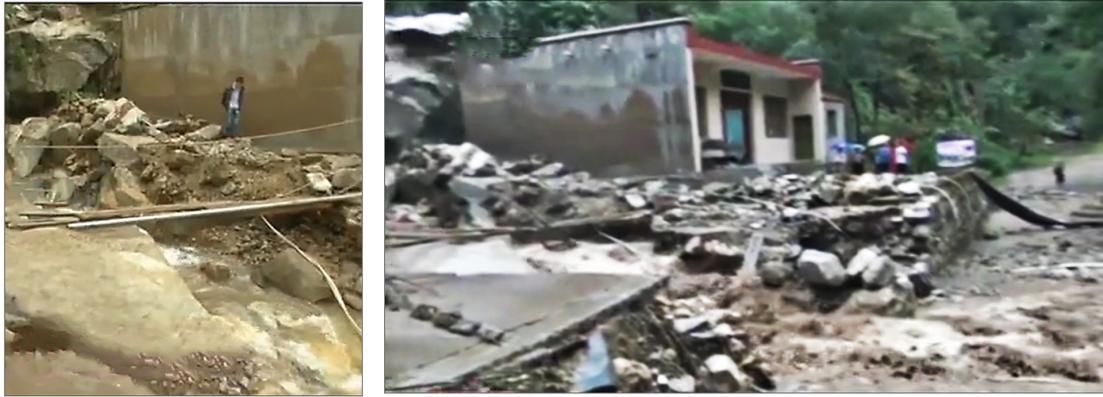
**Figure 2** Some debris (a) and destroyed roadbed (b) after the flood event at the mouth of the Shimen Valley

71 The flood flow from Shimen Valley, a tributary of the Xiaoyu River, washed nine  
72 people into the Xiaoyu River, seven of whom were killed with the remaining two  
73 missing. The rainfall was 145.7mm, reaching the highest value of a flood event in the  
74 30 year monitored period. Some snapshots after the disaster are shown in Figure 2;  
75 these snapshots illustrate large amounts of debris carried by the flood destroyed the road  
76 crossing the flow path.

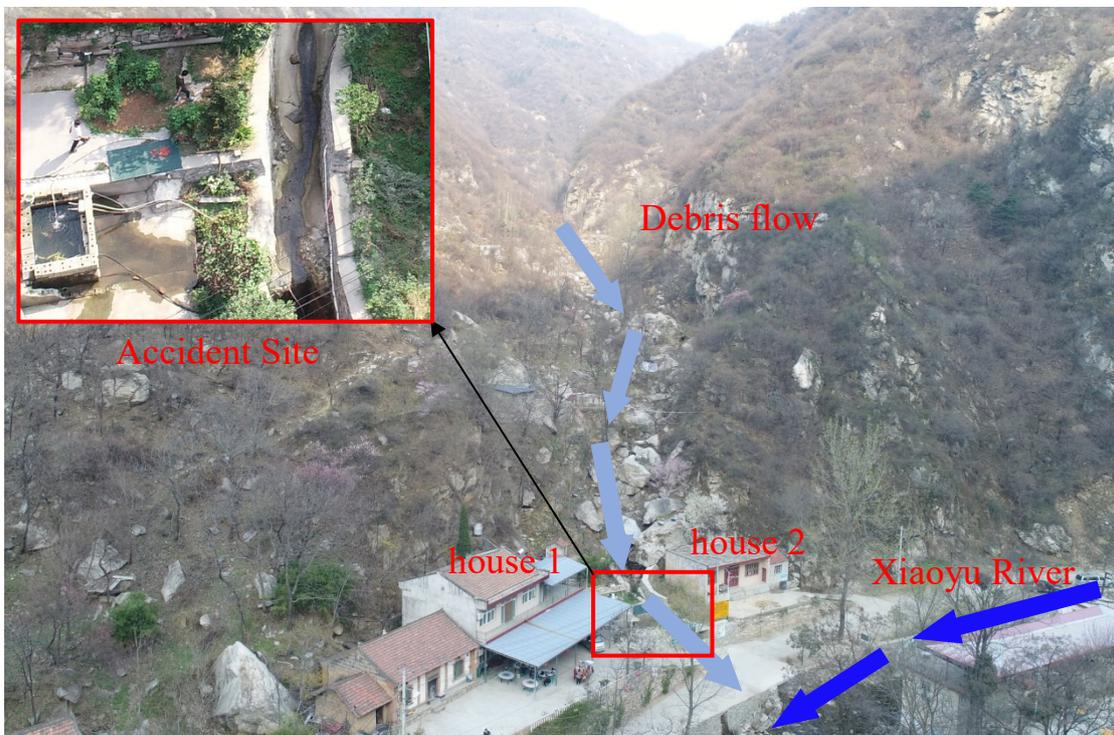
**Figure 3** The aerial view map of the Shimen Valley and the accident site

The field survey discovered that a barrier lake was formed at a narrow section of the valley by debris transported by the flash flood. More and more water was stored in the reservoir until it was full. When the water level was high enough to overtop the embankment, a dam break occurred and the wave began to propagate downstream the channel, causing severe flash flooding. Figure 3 shows an aerial view of the study area. It should be noted that the scene of the accident site is different in Figures 2 and 3, as a concrete channel was built after the flood event to raise the capacity of the flow conveyance channel.

197 According to the field investigation, photos and videos from the witnesses, the  
198 flood in the mouth of the valley reached very high levels; flood marks on the wall of  
199 house 2 in Figure 3 is about 2m high. In order to validate the hydrodynamic model, a  
200 comparison point was set near the wall. The computed depth hydrograph in Figure 12  
201 shows that the highest predicted depth is nearly 1.8m. Thus, the simulation results is  
202 close to the measured water level. Figure 13 also shows the velocity of the flood in the  
203 valley mouth at 42s when the flood reaches the highest value. At that time, the velocity  
204 around the house is about 9m/s, as Cox et al. (2010) investigate that the limited velocity  
205 for adults and children in good conditions is 3m/s, indeed, the kinematic energy is  
206 sufficient to cause the accident.

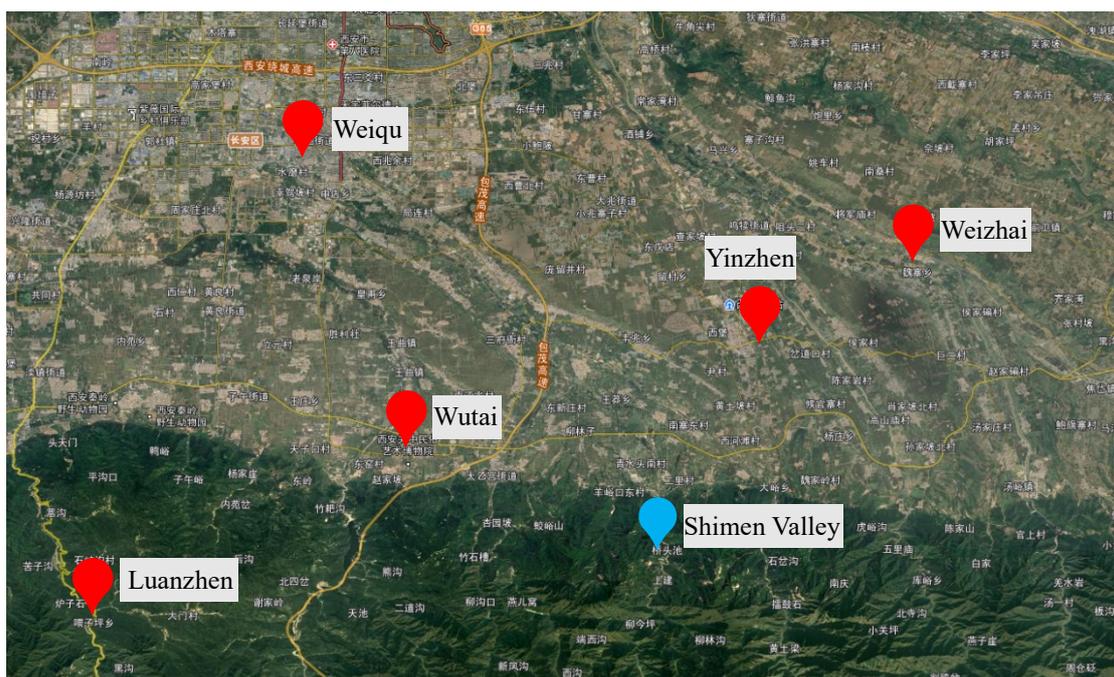
**Figure 4** Rain gauges around Shimen Valley

100 In order to understand the precipitation process of the event, the hydrography of  
101 the study area is required. As there is no rain gauge in the valley, the closest rain gauge,  
102 referred to as Yinzhen, was selected to represent the storm at the Shimen Valley (9.5km  
103 from the valley as plotted in Figure 4). The hyetograph at Yinzhen rain gauge is  
104 illustrated in Figure 5, indicating the rainfall increased sharply from 17:00 to 18:00, 3rd  
105 of August, 2018. The total rainfall was 144.8mm in 5 hours and reached 126.6mm in  
106 the first 2 hours. According to the IDF curves of Xi'an City in the form of a Chicago  
107 storm type, this rainfall is in a return period of around 1000 years. Such intense rainfall  
108 would be expected to produce large runoff and in turn lead to serve flooding.

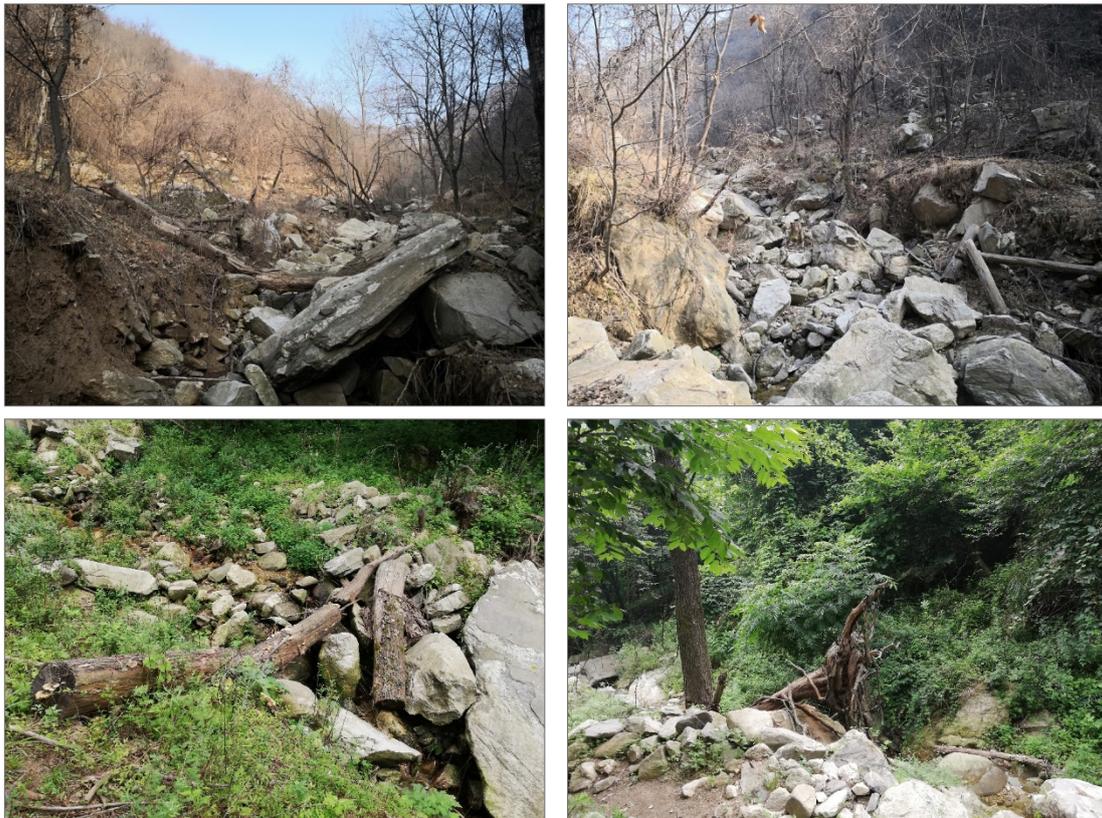
**Figure 9** Debris in the channel

In this disaster, the debris consisted mainly of boulders, rock fragments, logs,

sticks, branches and other wood that falls into the channel (see Figure 9). Figure 10

161 The boulders, as shown in Figure 9, are another kind of debris source. Once the  
162 flood velocity is adequate to carry the big stones, they will move downstream, mixed  
163 with the LWDs. When they arrive at the contraction section, the debris gathered and a  
164 barrier lake was formed with the carrying action of water. The water will be stored until  
165 the dam could not host the water. In this area, the thick trees play an important role for  
166 building the dam, since the trees worked as pillars to trap the coming debris.

- Apart from the heavy storm, the terrain characteristics are one of the main reasons for formation of the debris dam. The contraction existing in the channel provides a point for trapping of LWDs and boulders. Hence, additional flood risk analyses considering the potential for dam-breaks arising from debris dams is suggested for catchments where contractions in the river channel occur.
- Logs, sticks and branches are scattered over the channel and make an enormous contribution for the LWD forming the debris dam. The timely cleansing of the woody debris in the catchment, especially in the channel, is highly required. For example, an annual patrol can be arranged by the local authority and some big logs could be cut into pieces to avoid the river clogging

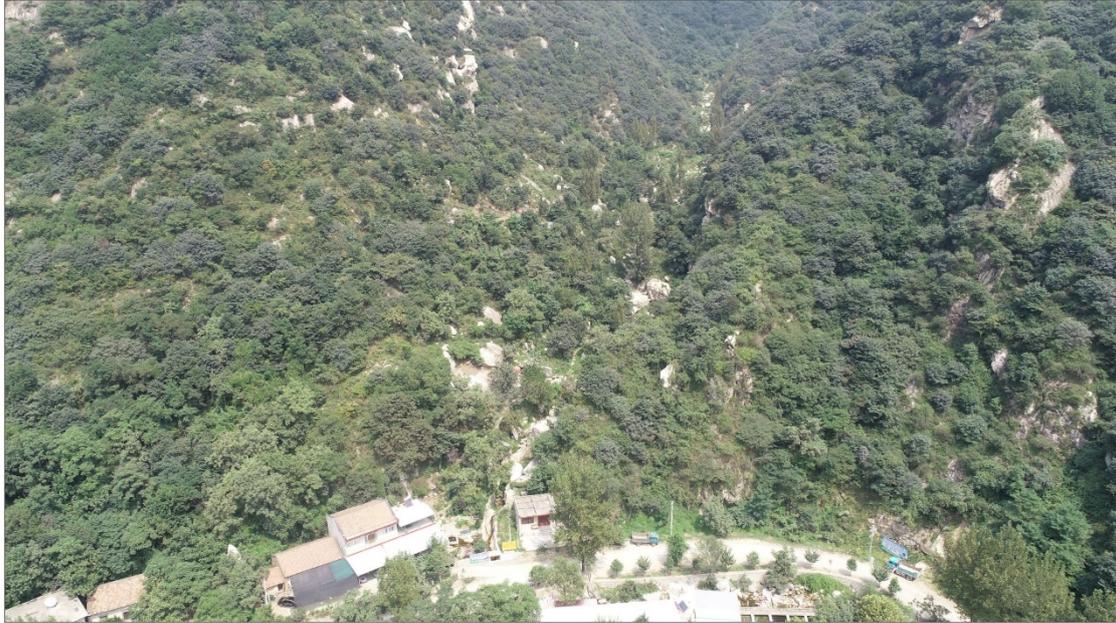
**Figure 10** Vegetation cover in the Shimen Valley

illustrates the thick vegetation cover in the Shimen Valley even in the river channel.

Apart from the shrub on the side slope, some trees in the channel were planted by the

local residents. Theoretically, the trees can increase surface roughness and reduce flood

peaks. But the logs, sticks and branches were distributed in the slopes and river channel,

most of them were not cleaned up in time. Once the heavy storm occurs, the fast runoff

will carry the Large Woody Debris (LWD) downstream and debris may destroy the

living big trees. Some trees growing in the contraction part of the channel would block
