## **Thermal characterisation of the clay binder of heritage Sydney sandstones**

### **Abstract**

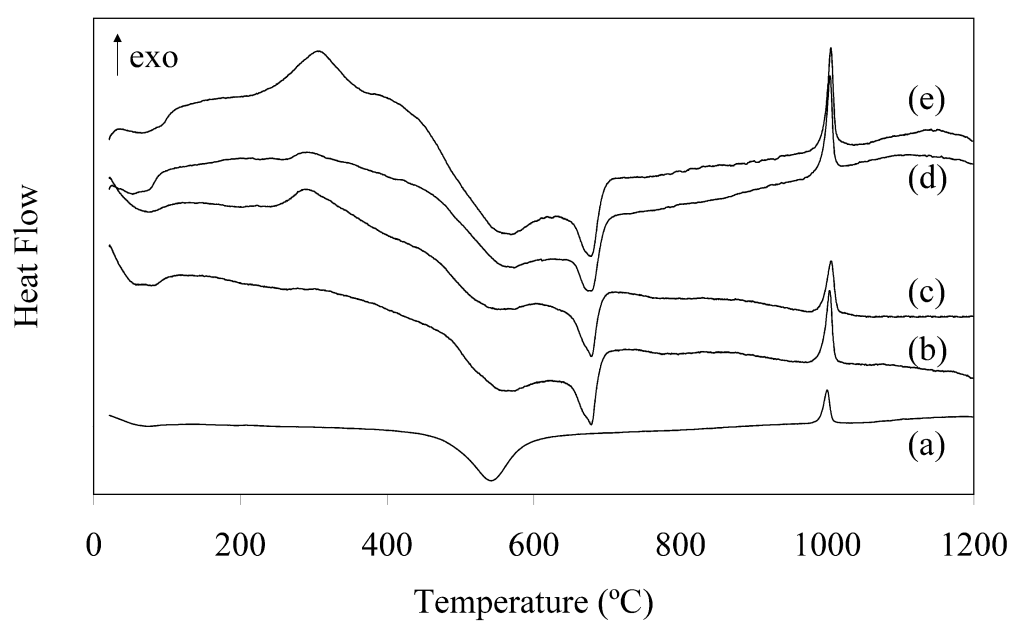
Figure 1. DSC traces of (a) standard kaolinite, (b) unweathered and (c) weathered clay before non-structural iron removal and (d) unweathered and (e) weathered clay after non-structural iron removal.

TGA and DSC analysis was carried out on weathered and unweathered clays before and after non-structural iron removal, as well as on a sample of standard kaolinite and the results are illustrated in Figures 1 and 2. The mass loss observed in the region  $30\text{-}130^\circ\text{C}$  in each of the DTG curves indicates the dehydration of the clay. The dehydration of kaolinite is also observed in the DSC traces with an endothermic peak observed between  $30^\circ\text{C}$  to  $130^\circ\text{C}$  in each case. The process is associated with adsorbed non-structural moisture being driven out of the clay particles.

Peaks in the range  $200\text{-}400^\circ\text{C}$  for all samples indicate the dehydration of iron oxyhydroxide,  $\text{FeO}(\text{OH})_x$ , and the crystallisation of iron oxide,  $\text{Fe}_2\text{O}_3$  [7-8]. The larger peaks observed in the weathered clay confirm that there are higher concentrations of iron impurities present in these samples. The leaching and oxidation of the detected iron impurities provides a source of iron for  $\text{Fe}^{3+}$  substitution for  $\text{Al}^{3+}$  and/or  $\text{Si}^{4+}$  in the kaolinite structure [1,9-10].

A dehydroxylation process is observed in the thermal data in the range  $450\text{-}750^\circ\text{C}$  and structural water is lost in this process. Hydroxyl groups in the clay structure are lost as water. During this process the structure of the kaolin clay breaks down to form water and metakaolin, which is a degradation product of kaolin clay with no binding power [11]. In this region in each of the DTG curves, a doublet with peaks centred at  $580^\circ\text{C}$  and  $680^\circ\text{C}$  is observed. The peak centred at  $580^\circ\text{C}$  corresponds to the dehydroxylation of kaolinite [12]. The second peak at  $650^\circ\text{C}$  is likely to correspond to a more thermally stable more ordered polymorph of kaolinite, dickite. This peak is present in both weathered and unweathered sandstones. The doublet is retained upon non-structural iron removal in both weathered and unweathered samples.

A sharp peak in each of the DTG and DSC curves observed in the region 980-1030°C is believed to be associated with the formation of mullite [1,4,13-15]. The formation of mullite, the thermal degradation product of kaolin clay in the weathered samples, indicates that the cementing material in the weathered sandstones retains its kaolin origin. The alteration of the crystal structure through iron substitution has not reached a state of complete destruction. Mullite is also detected in both weathered and unweathered clays after non-structural iron removal. This suggests that the clay structure is not altered by the non-structural iron removal method, in which only the adsorbed iron impurities were dissolved without removal of the structural metals.

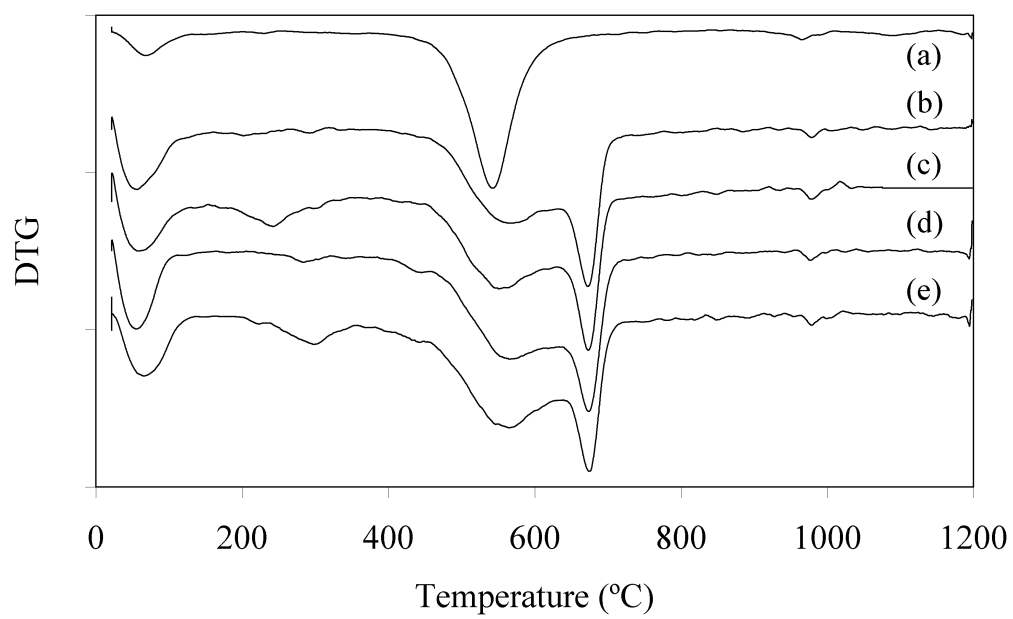
Figure 2. DTG data for (a) standard kaolinite, (b) unweathered and (c) weathered clay before non-structural iron removal and (d) unweathered and (e) weathered clay after non-structural iron removal.

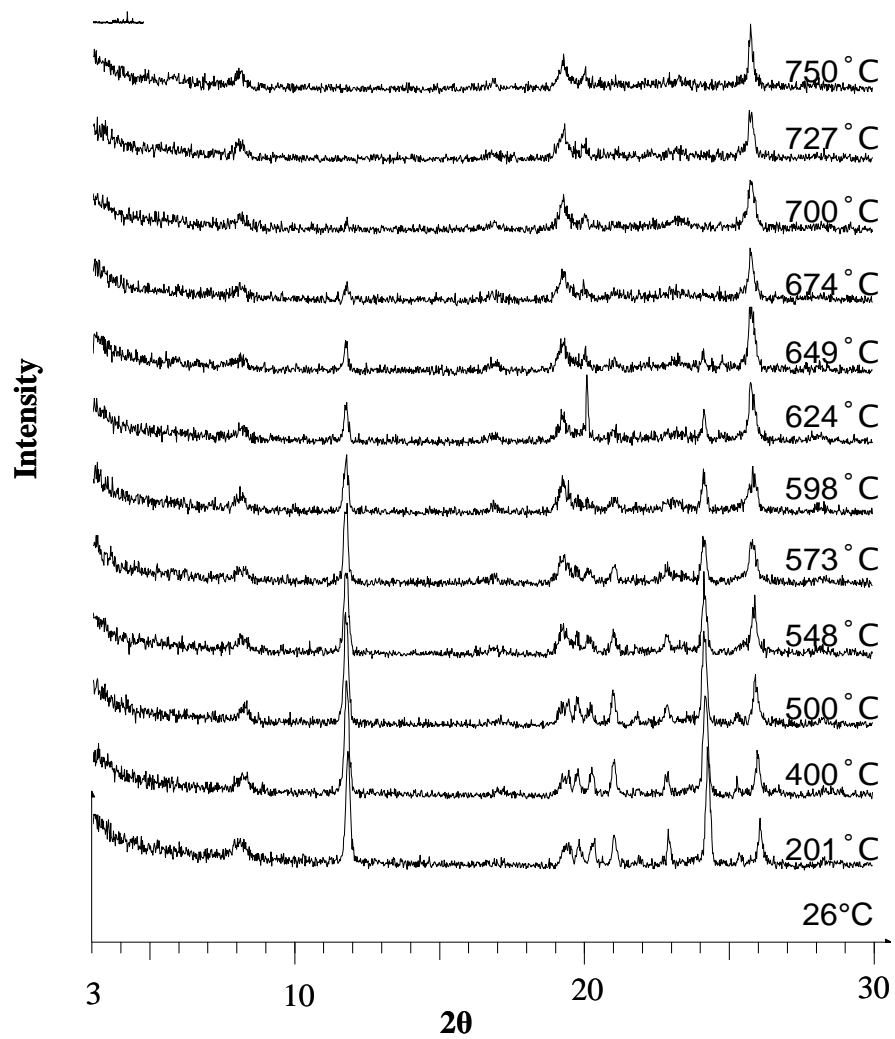
Figure 3. XRD patterns of the unweathered clay before non-structural iron removal.

XRD hot stage analysis was performed on the weathered and unweathered cementing clay samples before and after non-structural iron removal and the data are presented in Figures 3-6. The patterns of both the weathered and unweathered clay samples at room temperature contain peaks at  $2\theta = 12^\circ$ ,  $19.8^\circ$ ,  $21.3^\circ$  and  $24.5^\circ$  that are due to kaolinite. The peaks at  $2\theta = 12^\circ$  and  $24.5^\circ$  (basal  $d$  spacings of  $7.15\text{\AA}$  and  $3.75\text{\AA}$ , respectively) represent the preferred orientation of the  $(001)$  and  $(002)$  planes and the sharpness of these peaks suggests that it is a relatively high crystallinity (or more ordered) clay. The peaks at  $2\theta = 8.6^\circ$ ,  $17.6^\circ$ ,  $19.5^\circ$  and  $26.6^\circ$  (basal  $d$  spacings of  $10.3\text{\AA}$ ,  $5.06\text{\AA}$ ,  $4.56\text{\AA}$  and  $3.35\text{\AA}$ , respectively) represent the crystal planes of those from the mixed layer clays such as illite, muscovite and vermiculite [16-17]. The broadness of these peaks denotes less ordered (or more amorphous) crystal structures.

The peaks representing the kaolinite crystal planes in the unweathered clay samples before and after non-structural iron removal decrease in intensity at approximately  $550^\circ\text{C}$  and are completely destroyed at around  $700^\circ\text{C}$  (Figures 3 and 5). This result provides support for the theory of the presence of two types of kaolin clays in the cementing materials noted from the thermal analysis, where the original clay was destroyed at a temperature similar to that of the standard kaolinite. However, the second type of clay structure is not completely destroyed until around  $700^\circ\text{C}$ . This type of clay shows a stronger resistance to thermal degradation

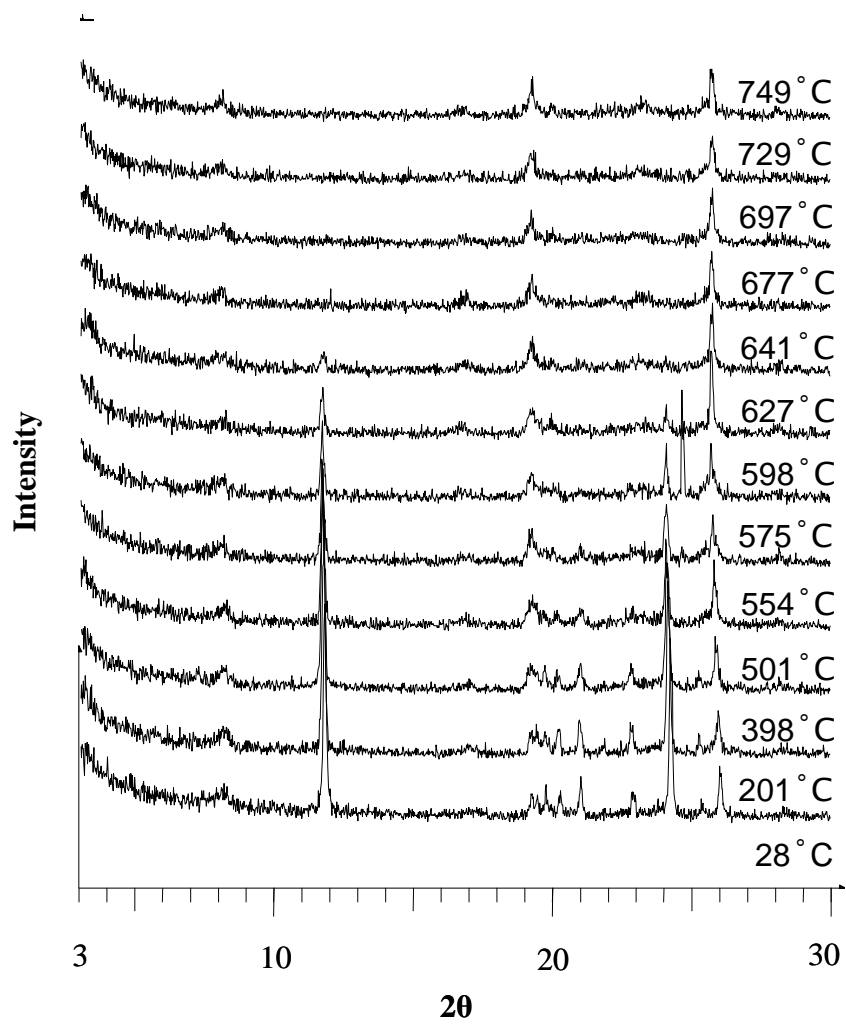
Figure 4. XRD patterns of weathered cementing clays before non-structural iron removal.

The XRD pattern of the weathered clay before iron removal shows a similar pattern to that of the unweathered clay. Although the kaolinite peaks start to decrease in intensity at the same temperature as the unweathered samples, the crystal structure is completely destroyed at around 650°C. The peaks representing the mixed layer clay fraction show a similar behaviour to that of the unweathered clay samples. XRD patterns of both weathered and unweathered clay samples after non-structural iron removal show a similar trend to clay samples before iron removal, but the unweathered samples are slightly more resistant to heating.

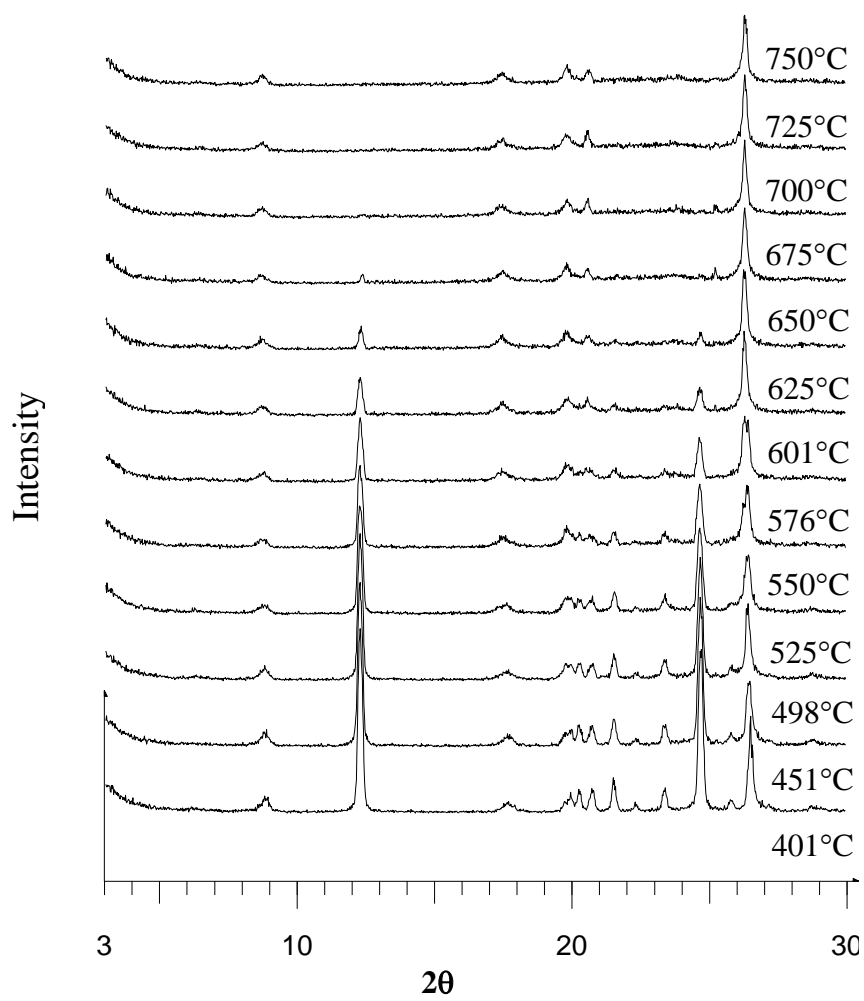
Figure 5. XRD patterns of unweathered cementing clays after non-structural iron removal.

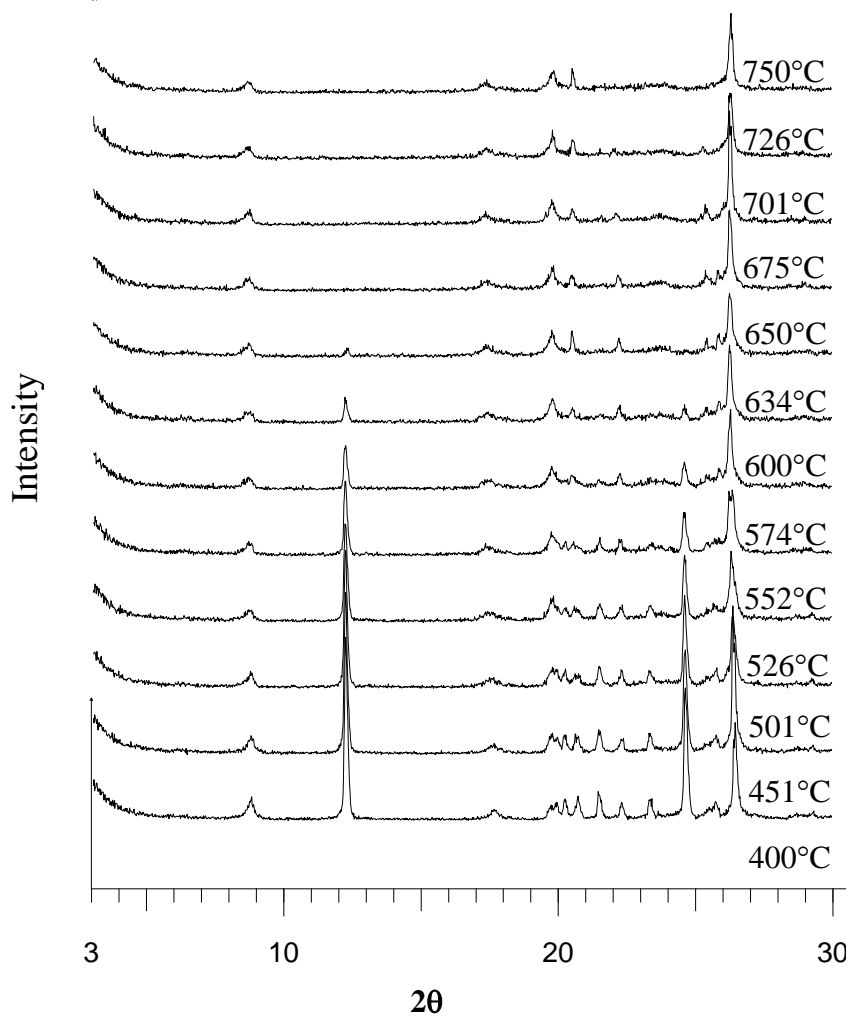
Figure 6. XRD patterns of weathered cementing clays after non-structural iron removal.
